# Bathymetric Surveys at Highway Bridges Crossing the Missouri and Mississippi Rivers near St. Louis, Missouri, 2010

Scientific Investigations Report 2011–5170

By Richard J. Huizinga

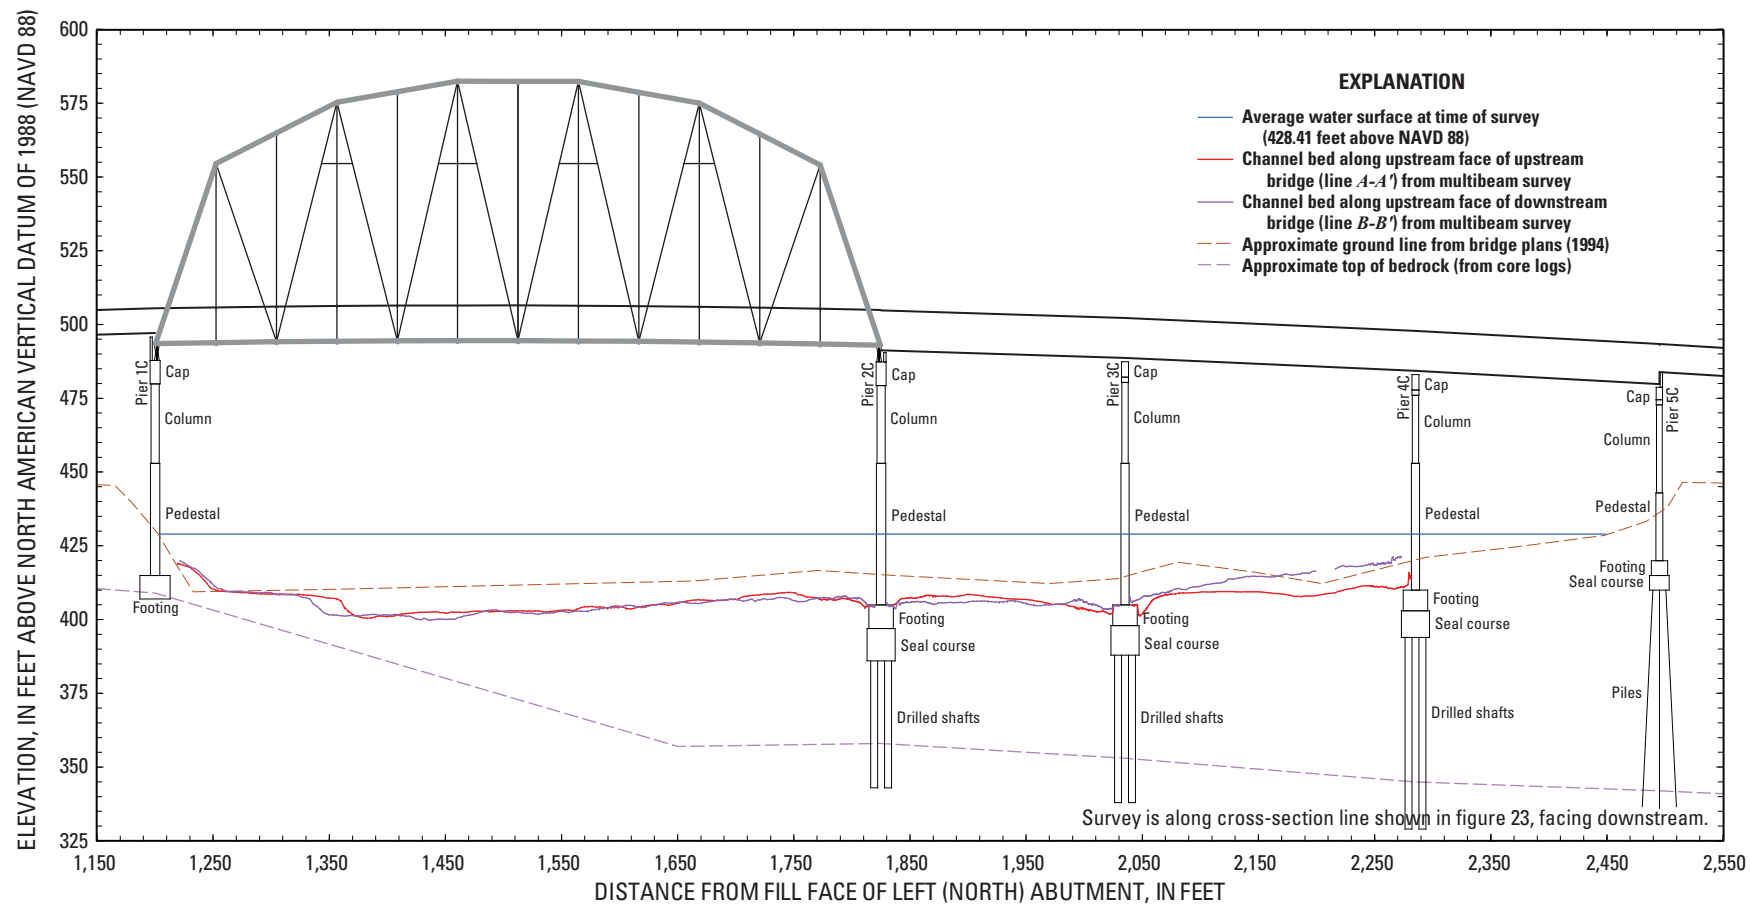
**Figure 26.** Key features, substructural and superstructural details, and surveyed channel bed along the upstream face of each bridge of dual bridge structure A4557 on State Highway 370 over the Missouri River near St. Louis, Missouri.

As with upstream structure A5585, information from bridge plans indicates that both bridges of structure A4557 are exactly the same in cross section for the part of the bridges across the main channel, which permits the cross-section data for each bridge to be examined together (fig. 26). The main channel piers of both bridges of structure A4557 are founded on shafts drilled 15 ft into bedrock (fig. 26; table 6). Depth of bed material between bedrock and the bottom of the various scour holes at dual bridge structure A4557 ranges from 43 to 67 ft because of the sloping bedrock and channel bed in the area (fig. 26; table 6). The minimum elevation in each of the scour holes is more than 9 ft higher than the bottom of the seal course elevation at each pier (fig. 26; table 6). The surveyed bed appears to be about 8 ft lower than the original ground line from bridge plans at the time of construction in 1994 (fig. 26). Although the footing of upstream pier 3C is exposed (figs. 24, 25), the exposure is minimal compared to the overall substructure that remains buried (fig. 26).

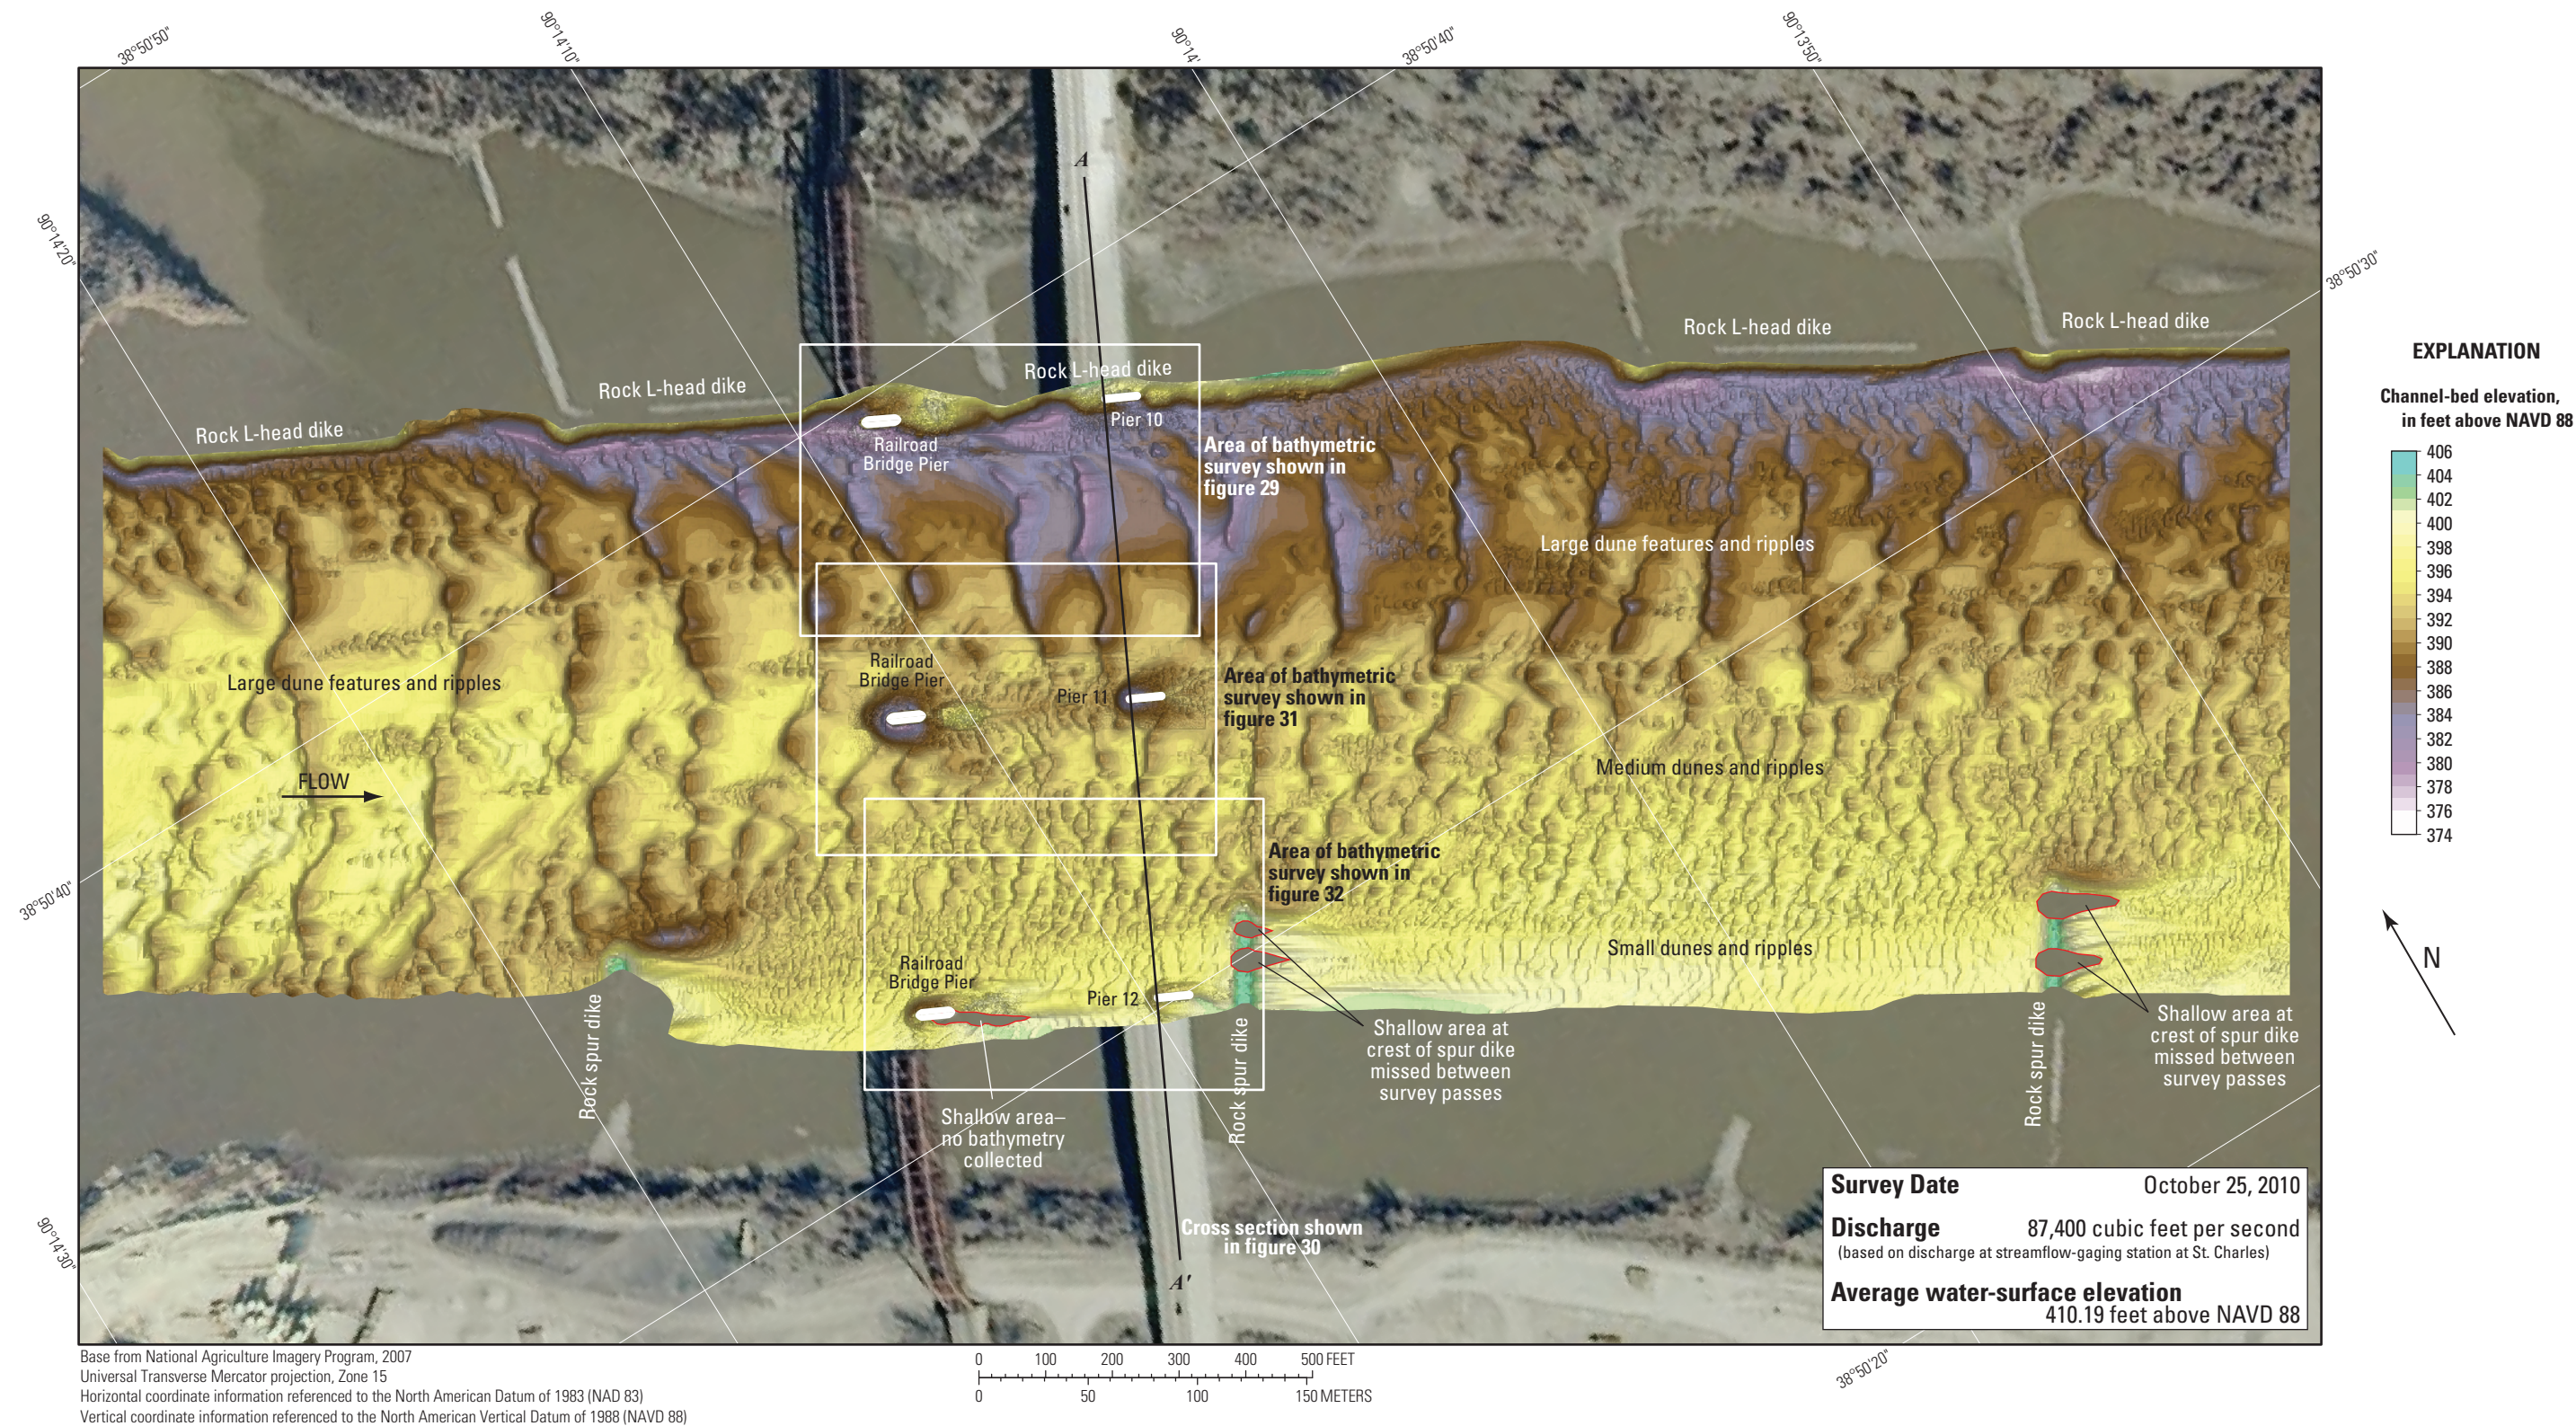
no long-term net degradation or aggradation at this site. The multibeam survey captures both the thalweg and the correct location of the L-head dike (figs. 28, 30), whereas the Level II survey appears to have a gap in stationing between the bathymetry point near pier 10 and the next point in the channel, essentially not capturing the thalweg. The L-head dike on the left bank is indicated as part of the 1974 ground line from bridge plans, but the plans indicate that the dike protrudes further into the channel.

Figure 28. Bathymetric survey of the Missouri River channel in the vicinity of structure A3047 on U.S. Highway 67 near St. Louis, Missouri.

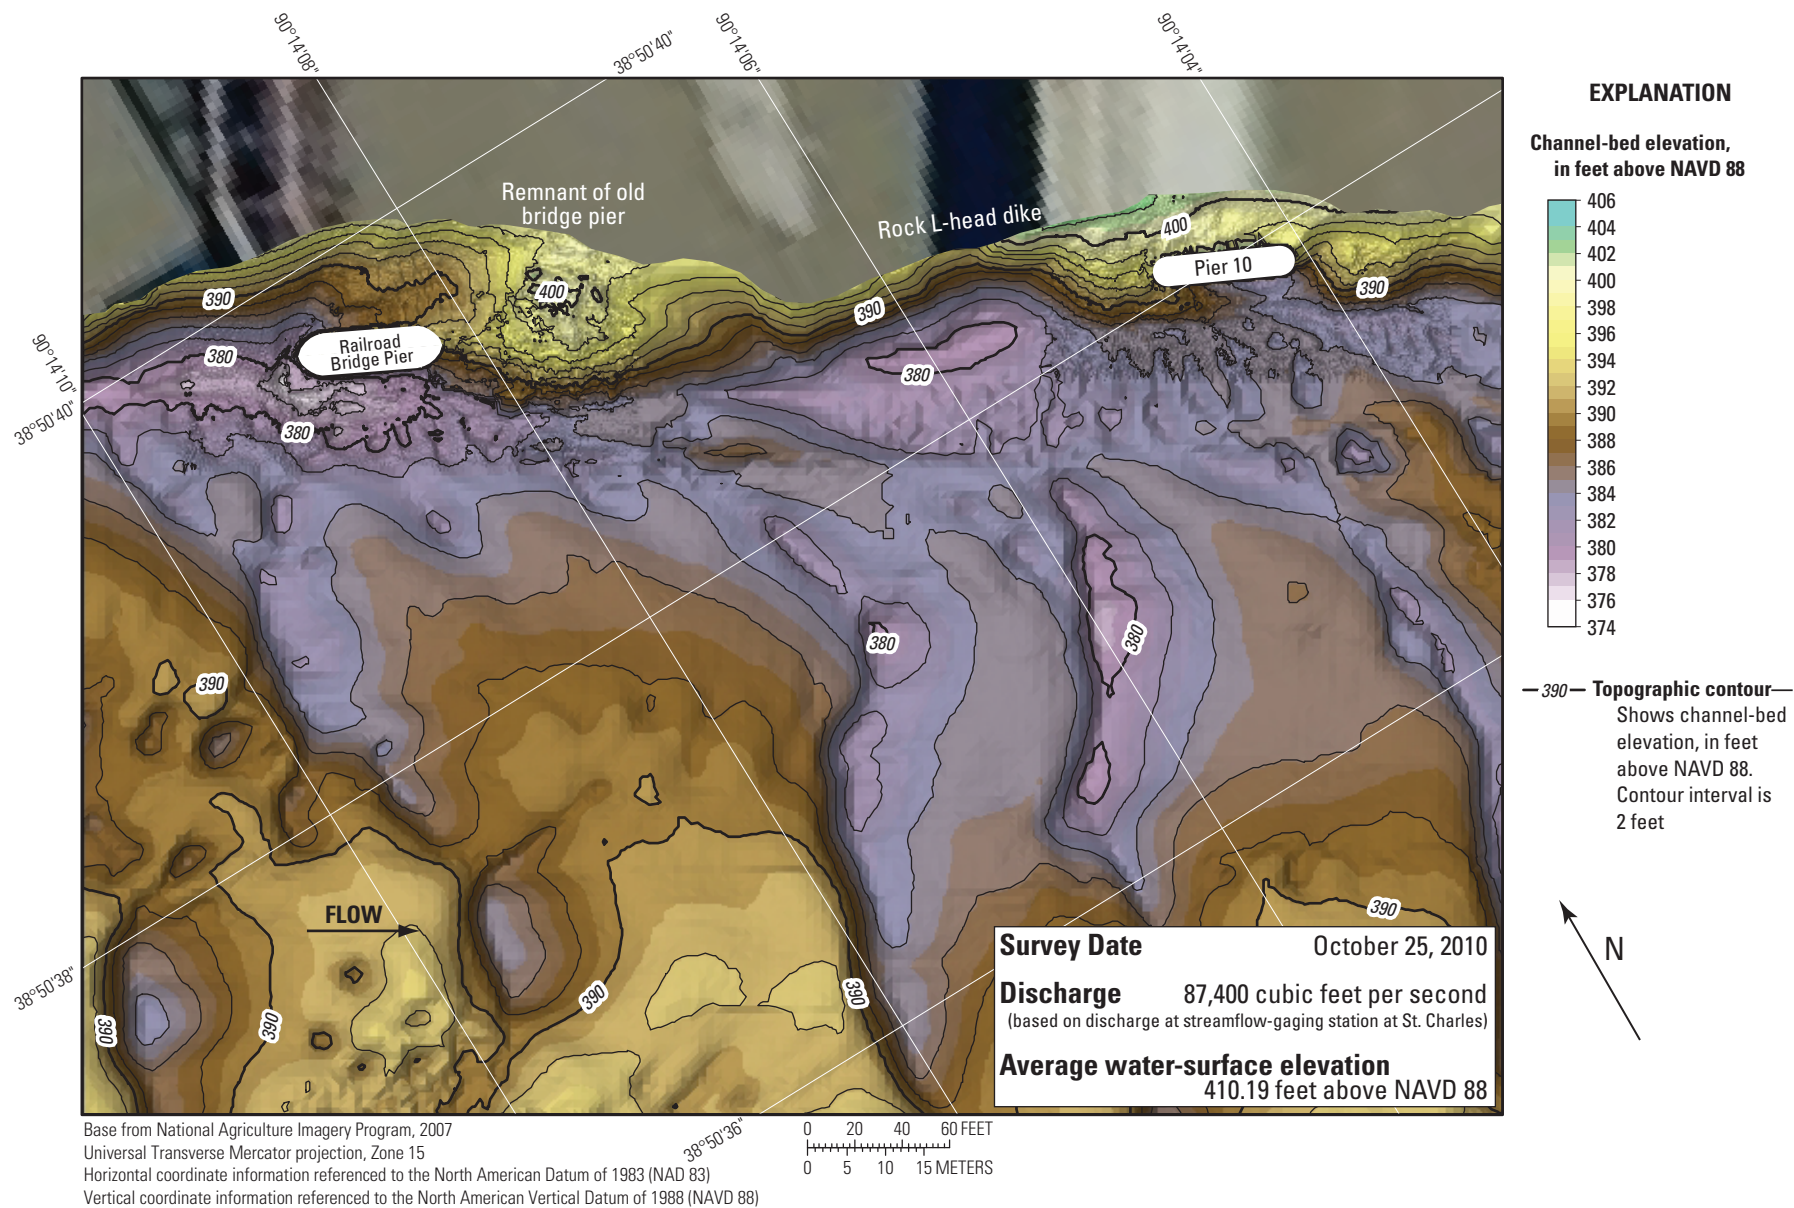
**Figure 29.** Bathymetric survey of the Missouri River channel in the vicinity of the left main channel pier of structure A3047 on U.S. Highway 67 near St. Louis, Missouri.

In the immediate vicinity of the left main channel pier (pier 10, fig. 29), the channel thalweg had a minimum elevation of about 383 ft (table 6), which is about 36 ft above the bottom of the seal course elevation of 346.50 ft (fig. 30; table 6). Pier 10 is essentially embedded in the rock of an L-head dike, which will limit or prevent scour at this pier (fig. 30). Information from bridge plans indicates that pier 10 is founded on shafts drilled 13 ft into bedrock, with about 80 ft of bed material between the channel thalweg and bedrock at the bridge, and about 89 ft of bed material between the bed at the

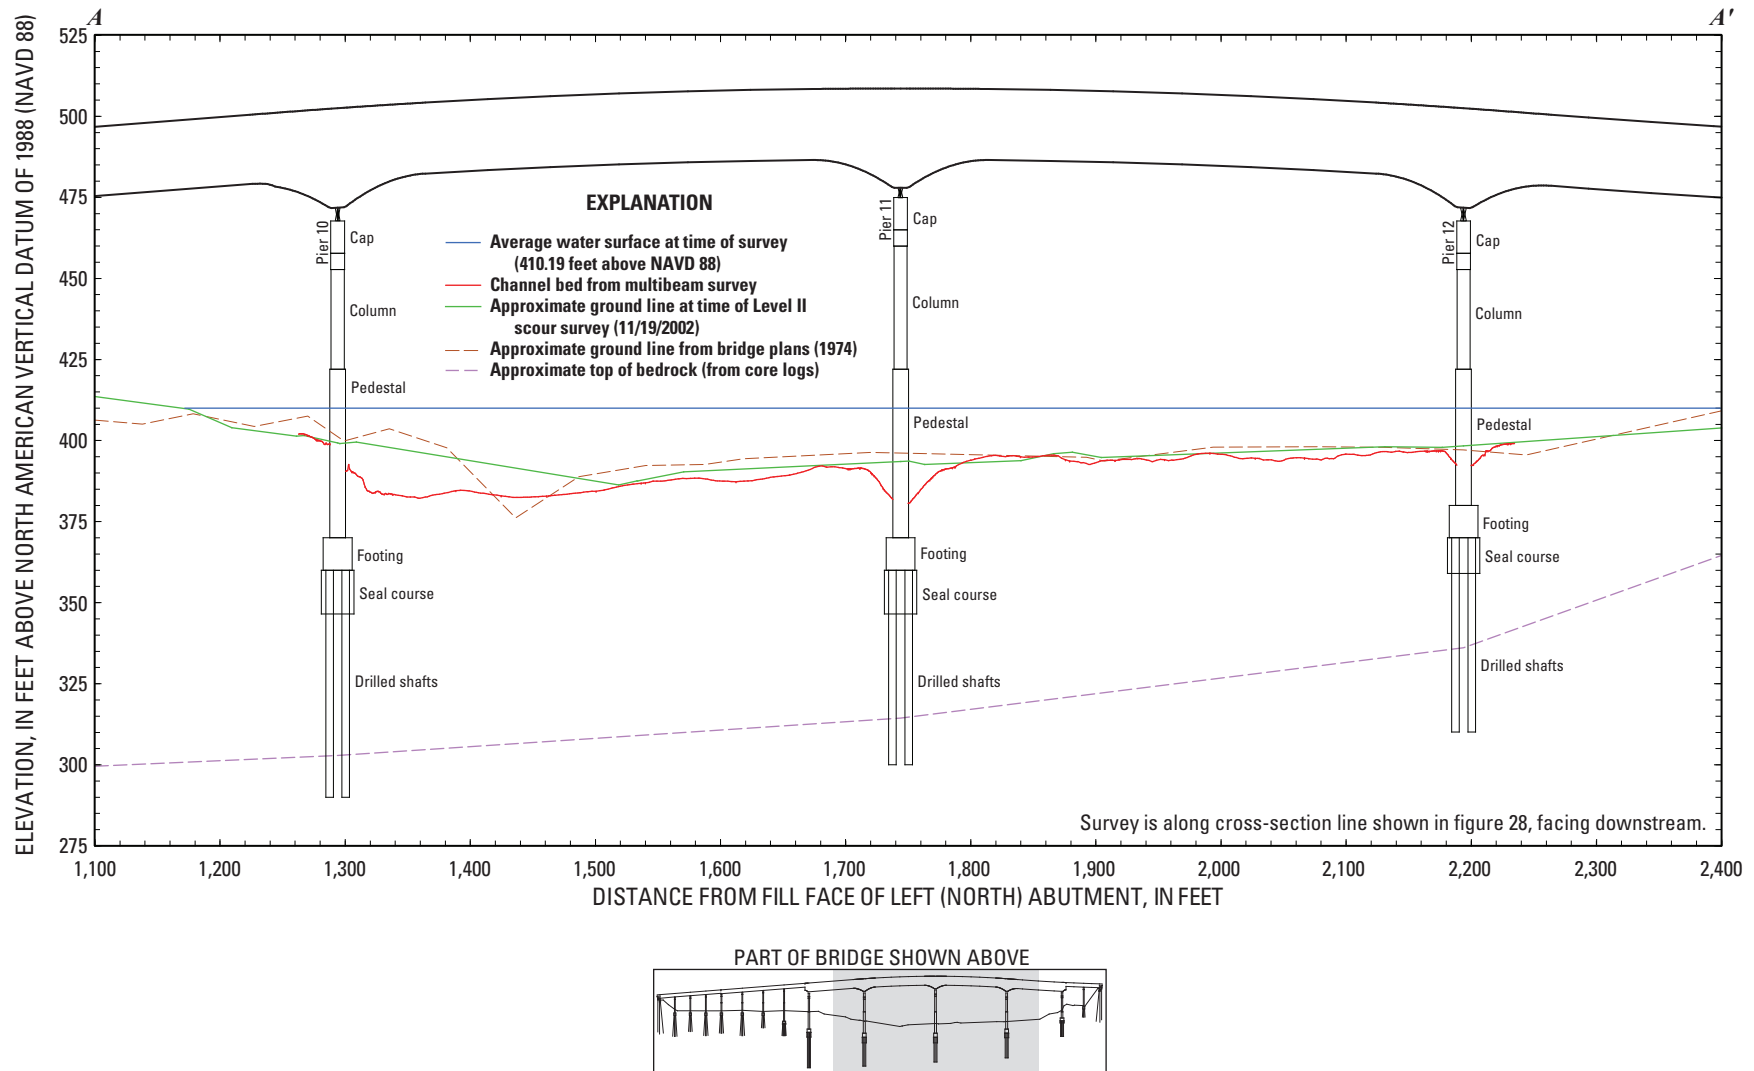
nose of the pier and bedrock (fig. 30; table 6). The scour hole in the vicinity of the upstream railroad bridge pier was essentially indistinguishable from the channel thalweg (fig. 29). The remnant of an old bridge pier was present in the channel downstream from the existing railroad bridge pier (fig. 29).

A Level II scour assessment was performed at this site in November 2002 (Huizinga and Rydlund, 2004), and the surveyed channel bed from the multibeam scan was similar to the channel bed from the Level II scour survey for most of the channel except the scour holes near the piers and the deep thalweg near the left (north) bank (fig. 30). Furthermore, the multibeam survey and the Level II survey are within 5 ft of the approximate ground line from bridge plans when the bridge was built in 1974, except near the left bank. The similarity of the bed elevations through time imply there has been little to

**Figure 30.** Key features, substructural and superstructural details, and surveyed channel bed of structure A3047 on U.S. Highway 67 over the Missouri River near St. Louis, Missouri.

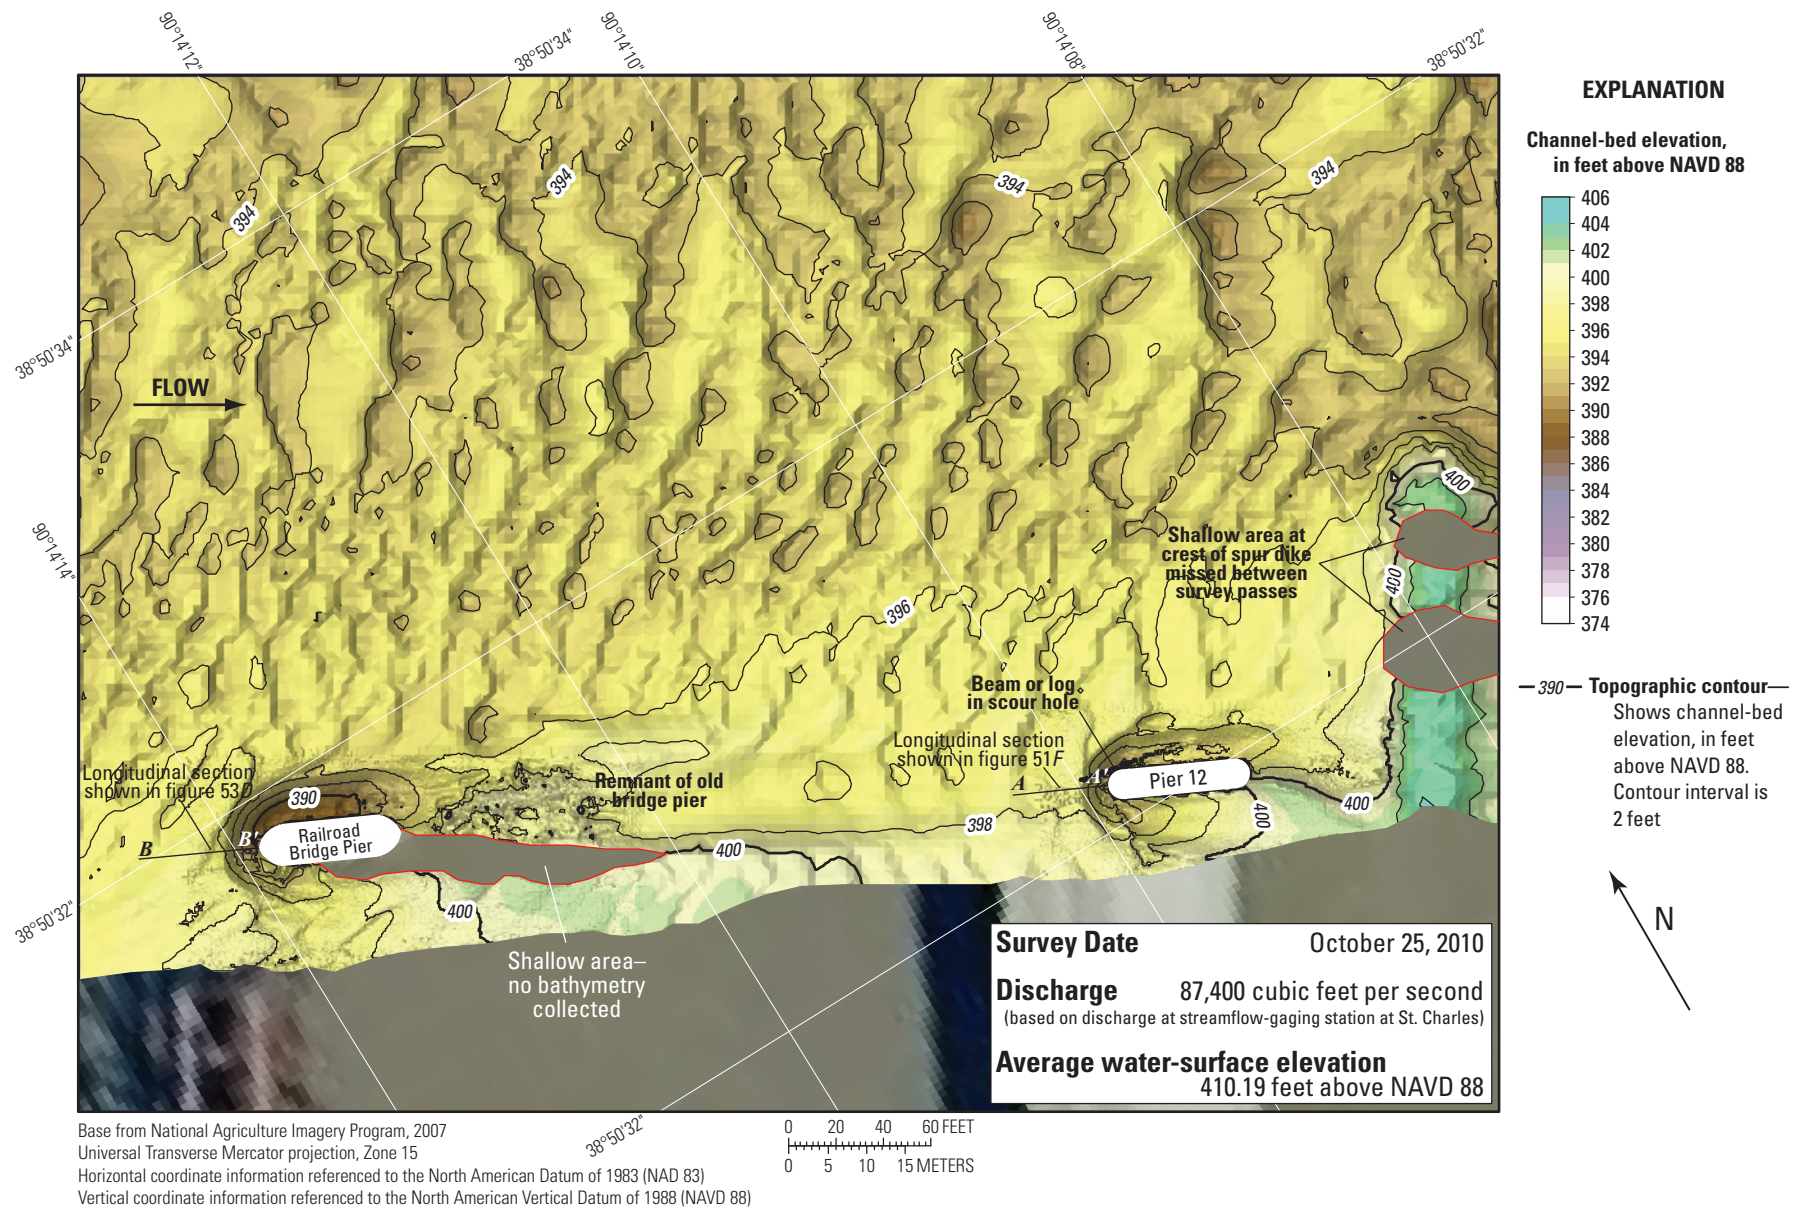
A small scour hole was present in the vicinity of the right main channel pier (pier 12, fig. 32), with a minimum elevation of about 392 ft, about 5 ft below the average channel bed immediately upstream from the pier (fig. 32; table 6). Information from bridge plans indicates that pier 12 is founded on shafts drilled 26 ft into bedrock, with about 56 ft of bed material between the bottom of the scour hole and bedrock (fig. 30; table 6). As with pier 11, a scour hole also was present in the vicinity of the railroad bridge pier upstream from pier 12, but it did not appear to have an effect on pier 12 (fig. 32). Once again, the remnant of another old bridge pier was present downstream from the existing railroad bridge pier, resulting in a shallow area where no bathymetry was collected (fig. 32).

**Figure 32.** Bathymetric survey of the Missouri River channel in the vicinity of the right main channel pier of structure A3047 on U.S. Highway 67 near St. Louis, Missouri.

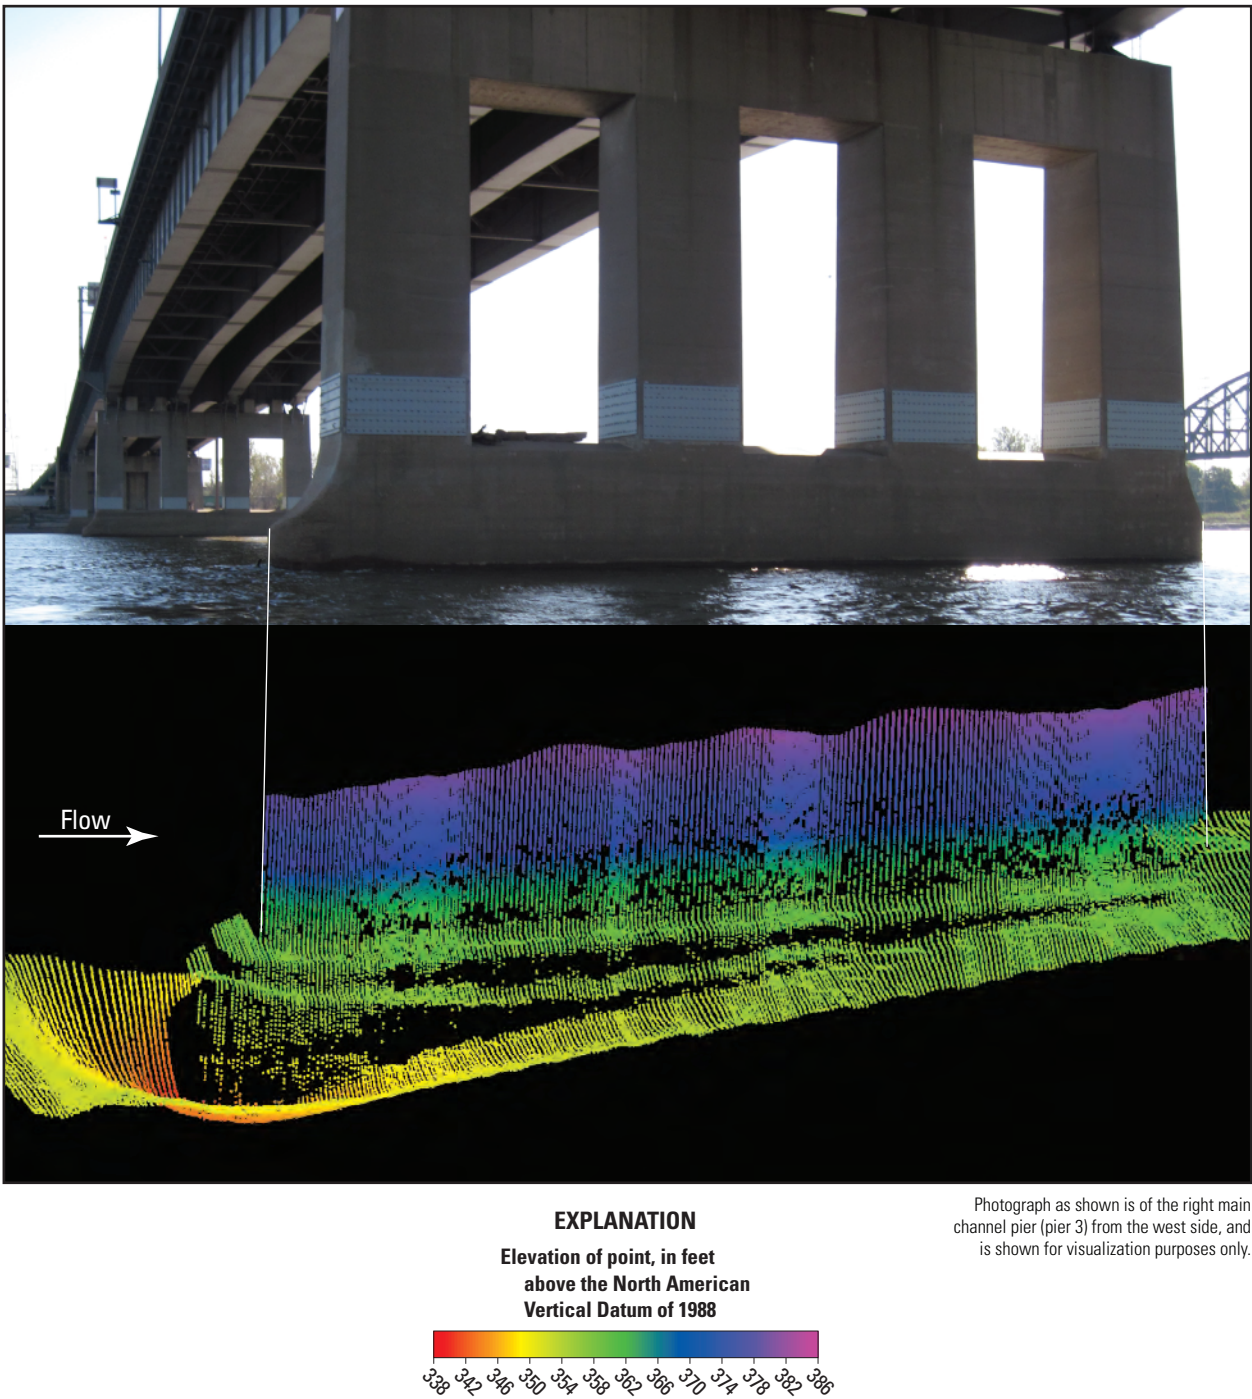
**Figure 37.** Point cloud visualization of the channel bed and right (west) side of the left main channel pier (pier 4) of structure A1500 on Interstate 55 over the Mississippi River near St. Louis, Missouri.

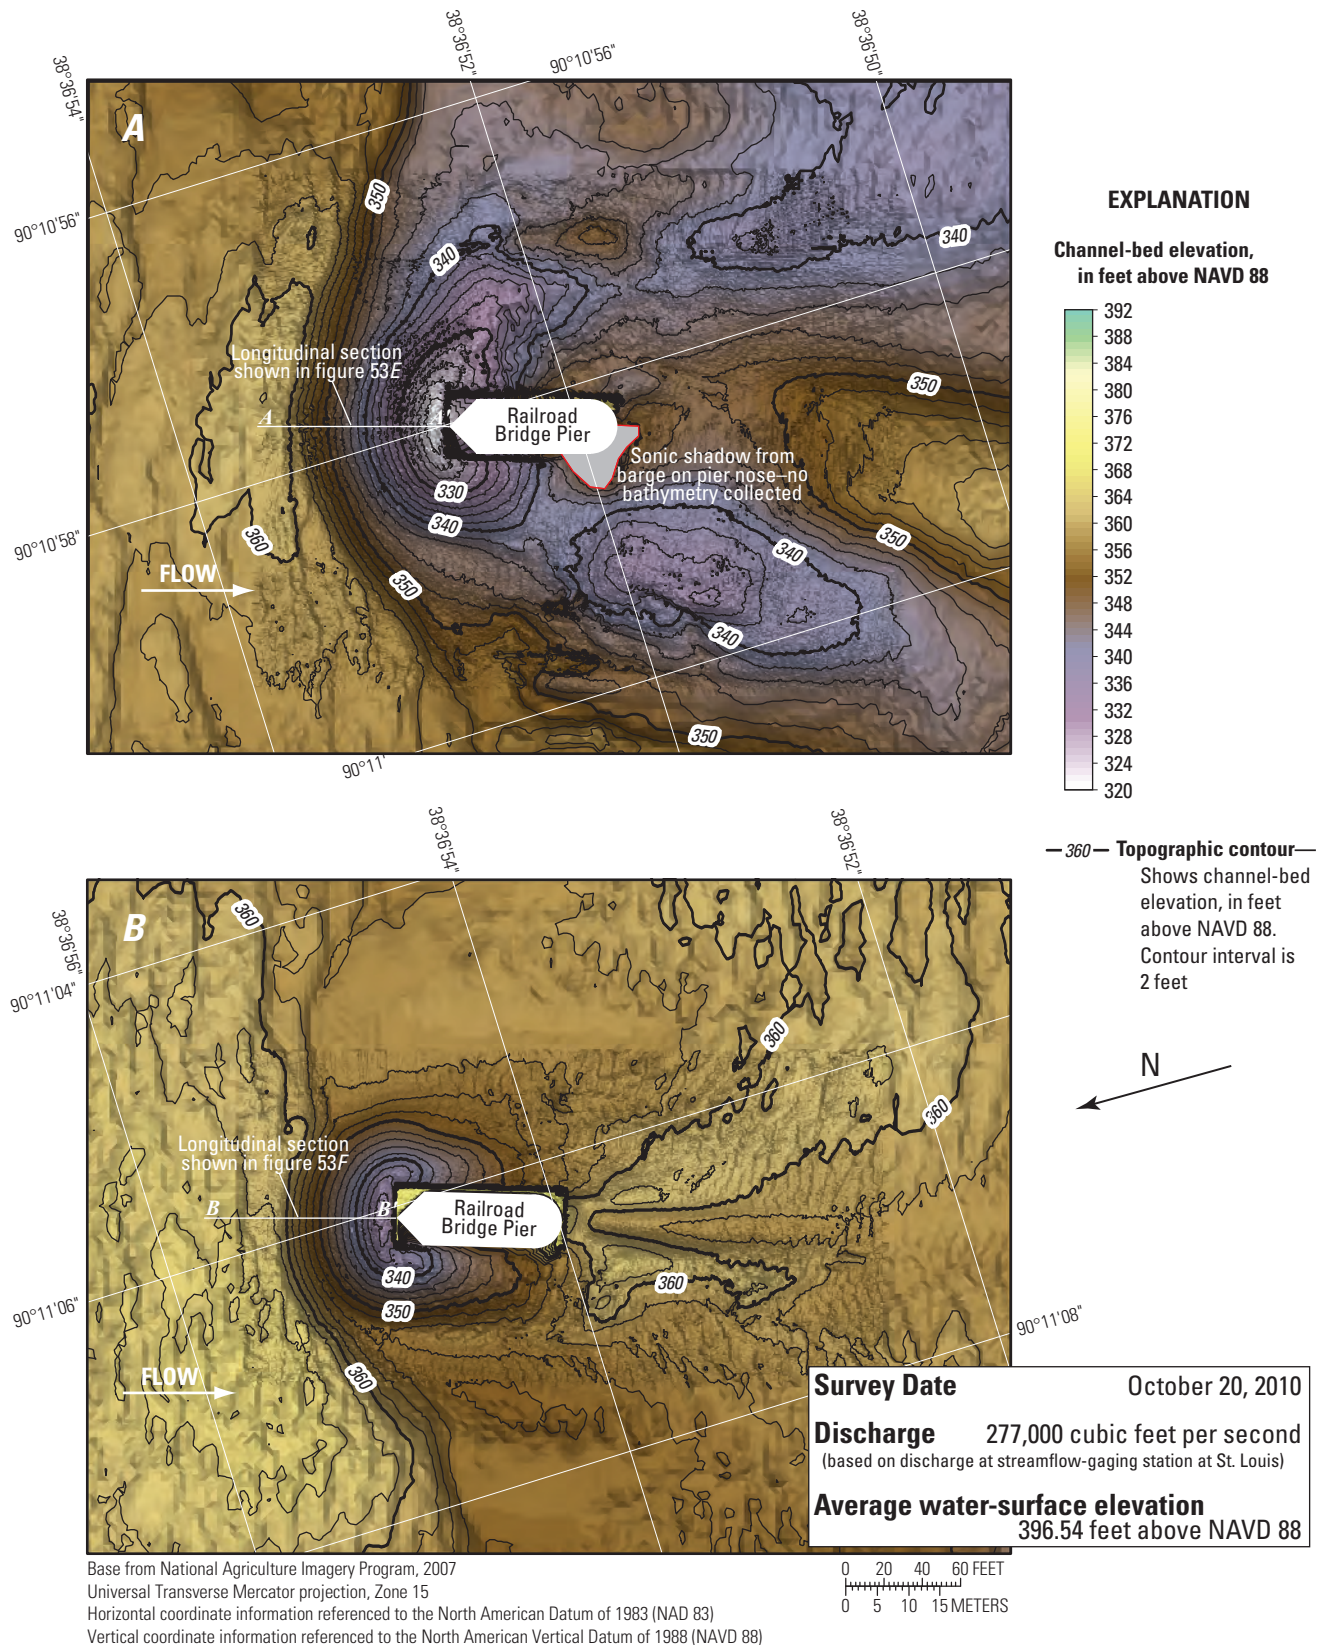
Substantial scour holes were observed at the MacArthur railroad bridge piers downstream from structure A1500 (fig. 39). In the vicinity of the left main channel pier (fig. 39A), the hole had a minimum elevation of 321 ft at the nose of the pier, which was the minimum elevation in the entire survey area (table 5) and about 40 ft below the average channel bed immediately upstream from the pier (fig. 39A). The size of this

scour hole is substantially affected by a partially sunken barge trapped on the nose of the pier (fig. 40). In the vicinity of the right main channel pier (fig. 39B), the hole had a minimum elevation of 333 ft at the nose of the pier, about 31 ft below the average channel bed immediately upstream from the pier (fig. 39B).

**Figure 39.** Bathymetric survey of the Mississippi River channel in the vicinity of the A, left and B, right main channel piers of the MacArthur Railroad Bridge downstream from structure A1500 on Interstate 55 near St. Louis, Missouri.

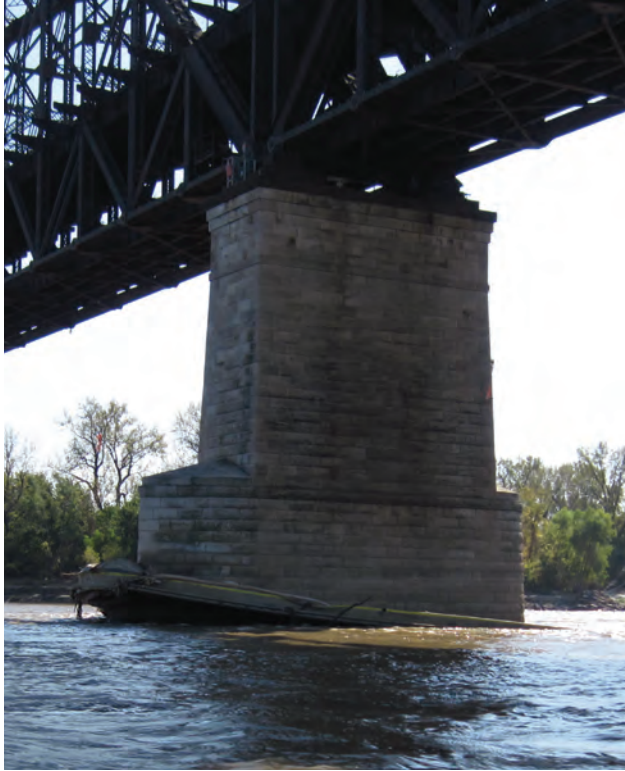
**Figure 40.** A partially sunken barge trapped on the nose of the left main channel pier of the MacArthur railroad bridge over the Mississippi River downstream from structure A1500 on Interstate 55 near St. Louis, Missouri.

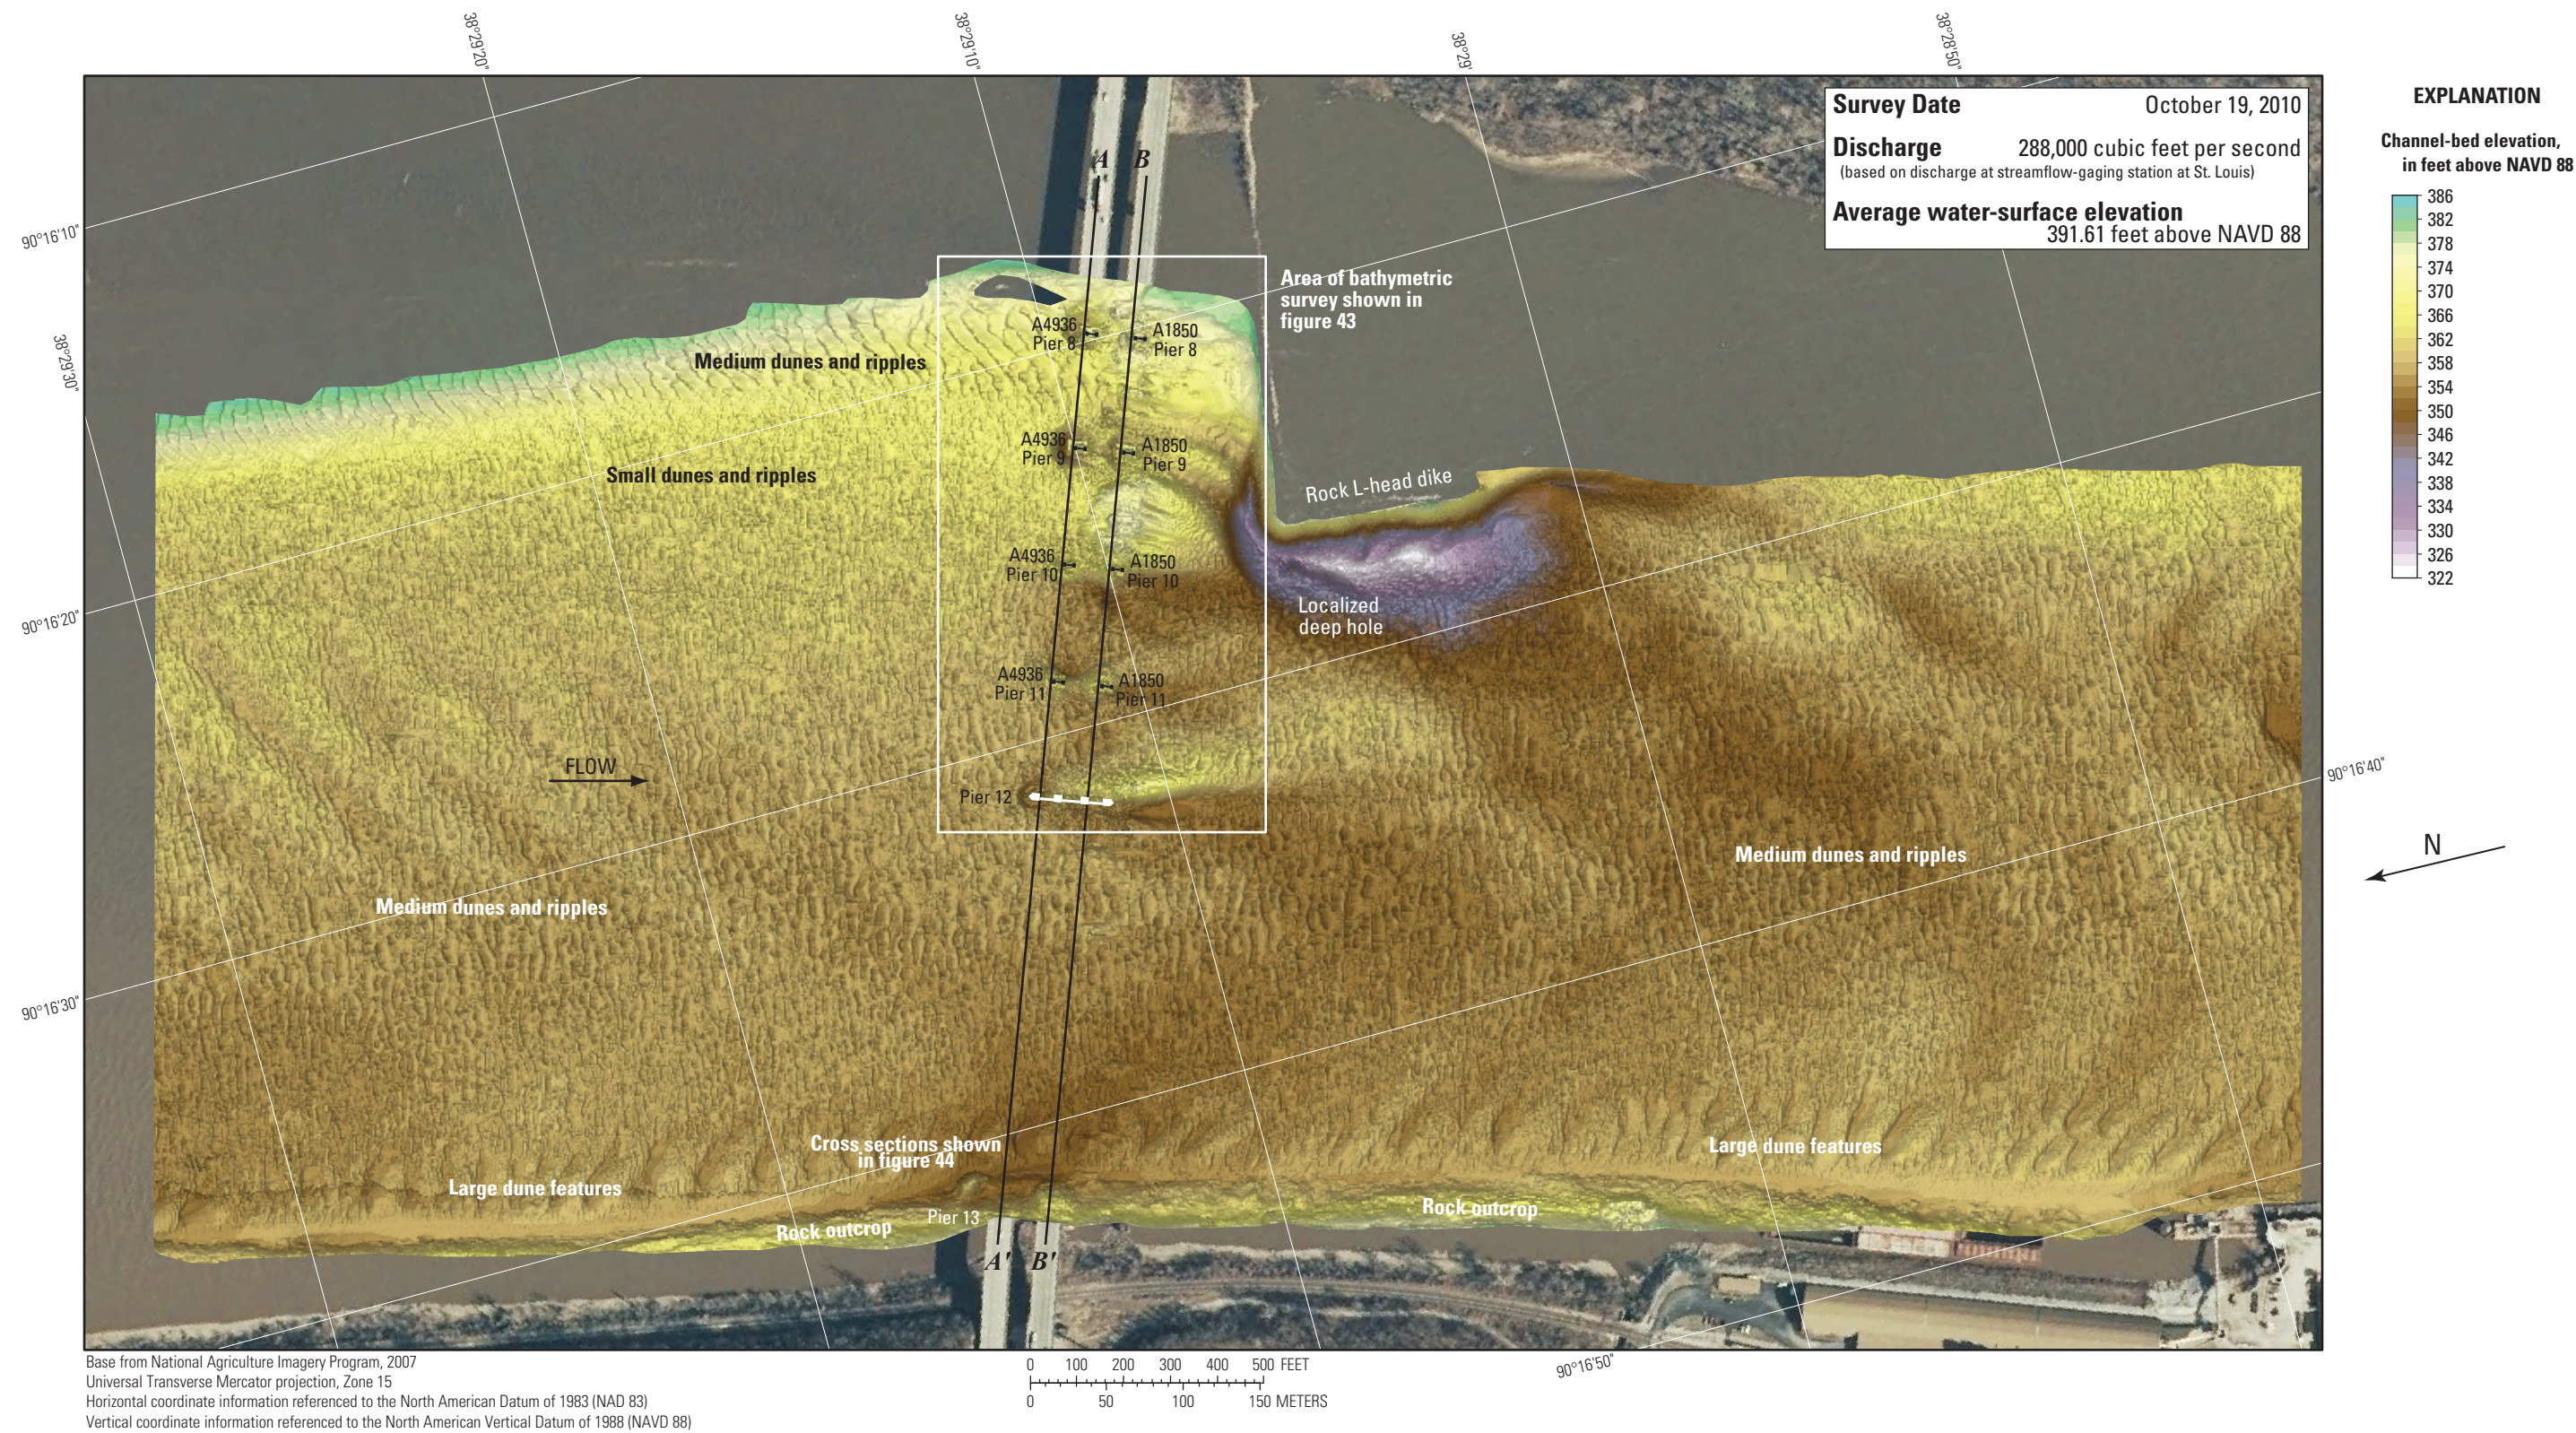
Figure 42. Bathymetric survey of the Mississippi River channel in the vicinity of structures A4936 and A1850 on Interstate 255 near St. Louis, Missouri.

The survey area was about 4,590 ft long and about 1,970 ft wide, extending from shallow areas on the left to the right bank in the main channel (fig. 42). The upstream end of the survey area was about 1,970 ft upstream from the centerline between structures A4936 and A1850 (figs. 41, 42). The channel-bed elevations ranged from about 352 to 371 ft for most of the surveyed area (5 to 95 percentile range of the bathymetric data), except in the localized deep hole near the large L-head dike on the left side of the channel downstream from the bridges, which had a minimum elevation of 323 ft (fig. 42). A shallow channel thalweg was along the right (west) bank (fig. 42). Larger dune features were detected along the rock outcrops on the right side of the survey area; the remainder of the channel was filled with medium and small dunes and ripples (fig. 42).
